Lackham's World War II hardened field defences, or Lackham's WWII "Pill boxes"

Tony Pratt ¹

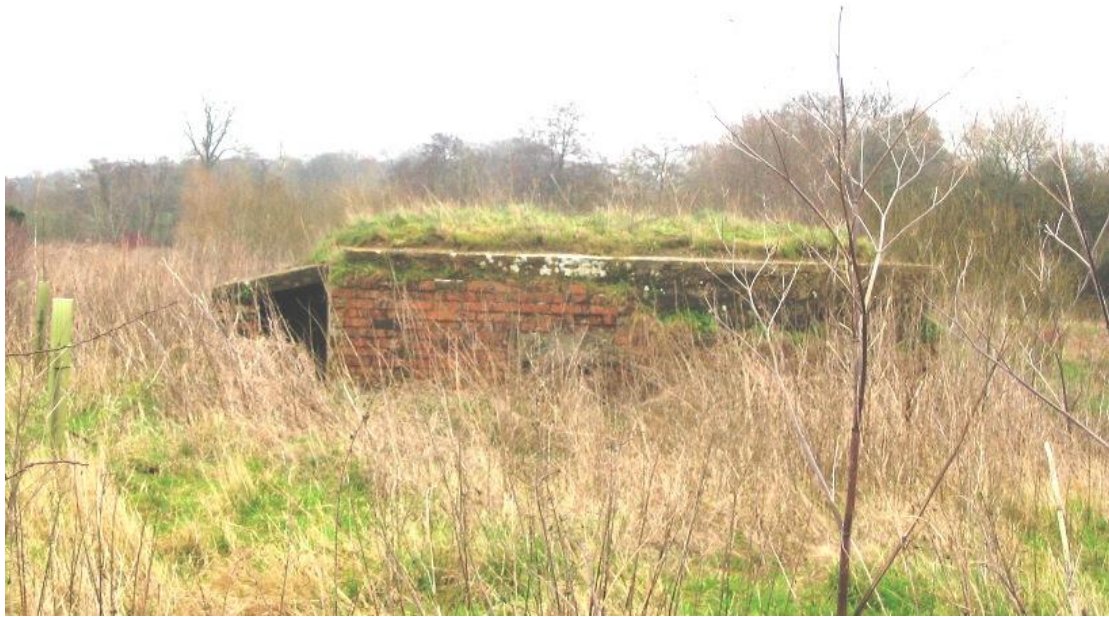
Number 1

1.1 View from the south west, R. Avon to the right

No. 1 is a Type 24 structure. This type is an irregular hexagon in plan. The rear wall is the longest at about 14 feet (4.3 m), and has the entrance, with an embrasure on either side. The other walls here are 8 feet (2.5 m), on the longer die for this type which varied between 7-8 feet in length. Each has a single embrasure.. Internally there is a Y shaped anti-ricochet wall (the top of the Y nearest the entrance), which helps support the roof. It is located on the top of the bank of the River Avon and is clearly visible. The brickwork is in very poor condition and substantial amounts have fallen off, revealing the concrete construction. Interior access is possible although there is much broken brickwork inside. The floor is very muddy in wet weather.

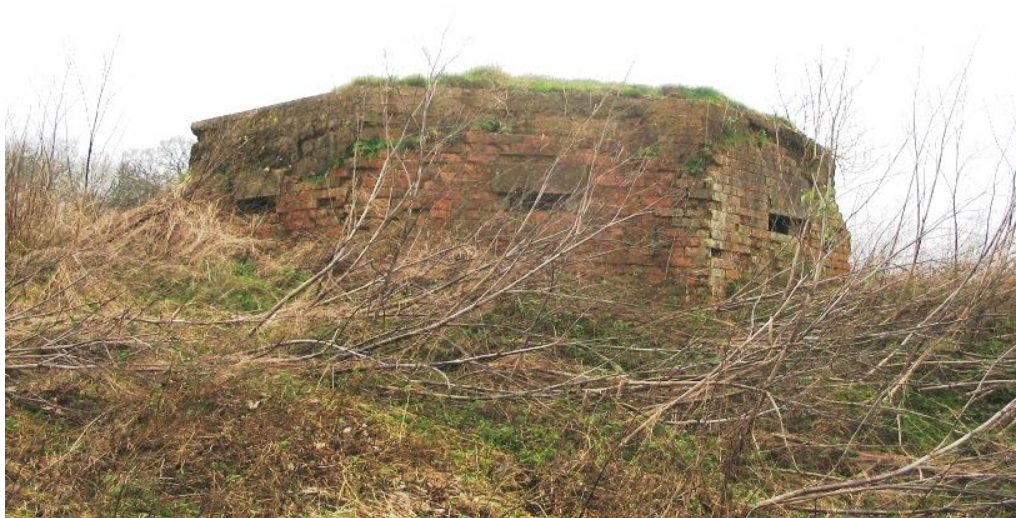
1.2 View from the bank of the River Avon looking north east

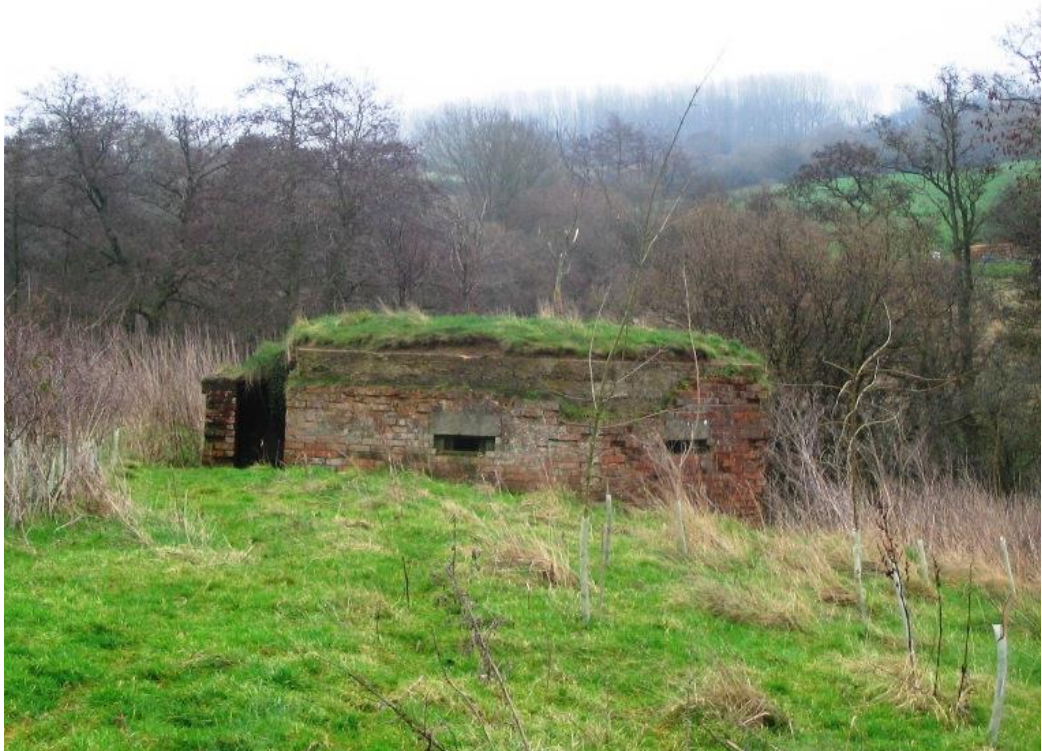
Number 2

2.1 View from the south east R. Avon to right

No. 2 is a Type 24 construction. The brickwork is in even worse condition than No. 1. Access to the interior is possible and it is dry and relatively uncluttered.

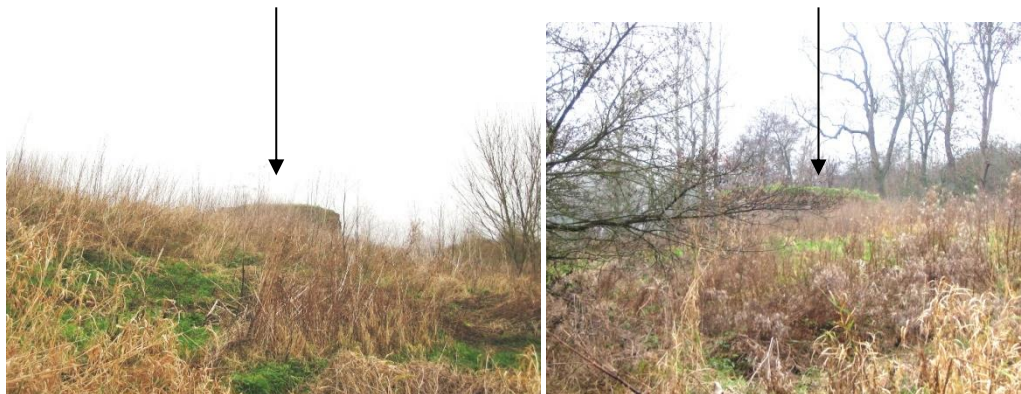
These first two structures are very close to each other, and were emplaced to guard the Hunting Bridge, which spanned the River Avon approximately midway between the two. The two pictures below show them as seen from the bridge support

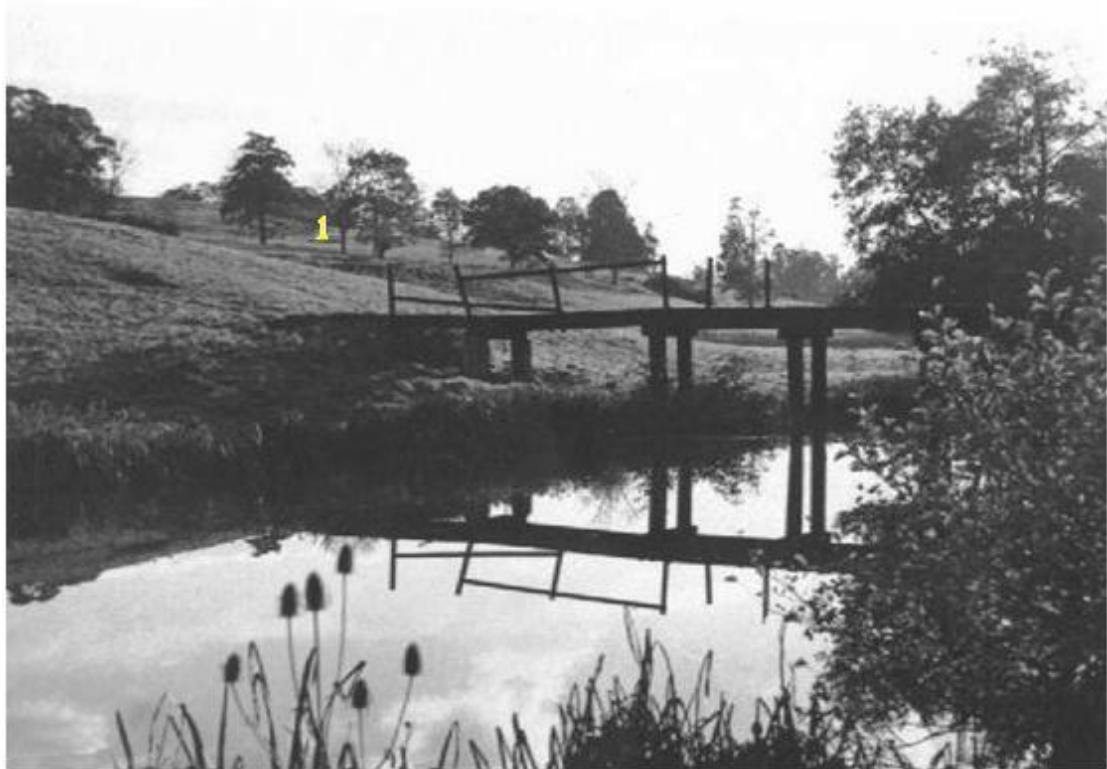
The illustration below is the only known view of the Hunting Bridge, and was taken from the western bank of the Avon just below one of the pill-boxes. The label 1 indicates the location of the Wilts & Berks canal

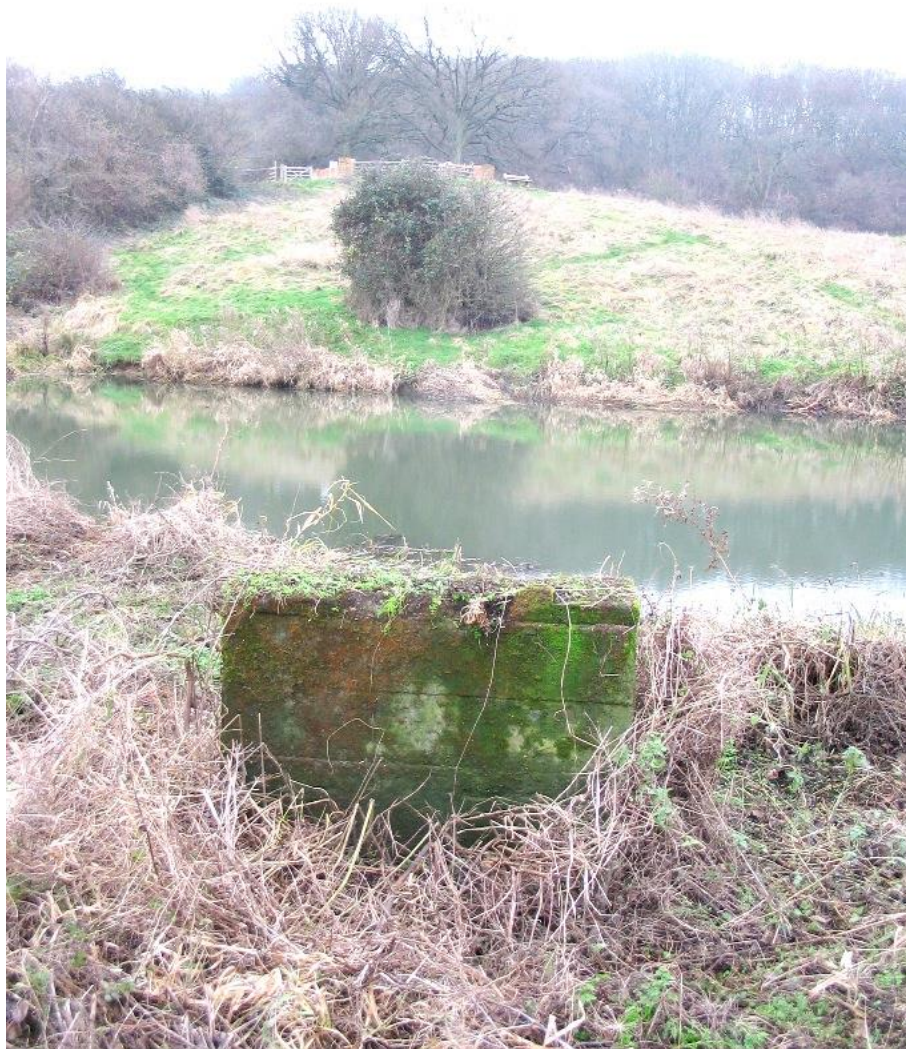
All that remains today is the bridge support pier. This is seen in the foreground of the next illustration where it is hidden in the clump of blackberries visible on the other side of the R. Avon. Although not clear in the illustration above it is possible that another pillbox was located in the fold on the land between the river and the canal but it is uncertain if this is the case and nothing can be seen there now.

Piers of the Hunting Bridge, looking east along the line of the bridge.

The objects behind the patch of blackberries on the eastern side of the river are on the Wilts and Berks Canal which runs parallel to the R. Avon here.

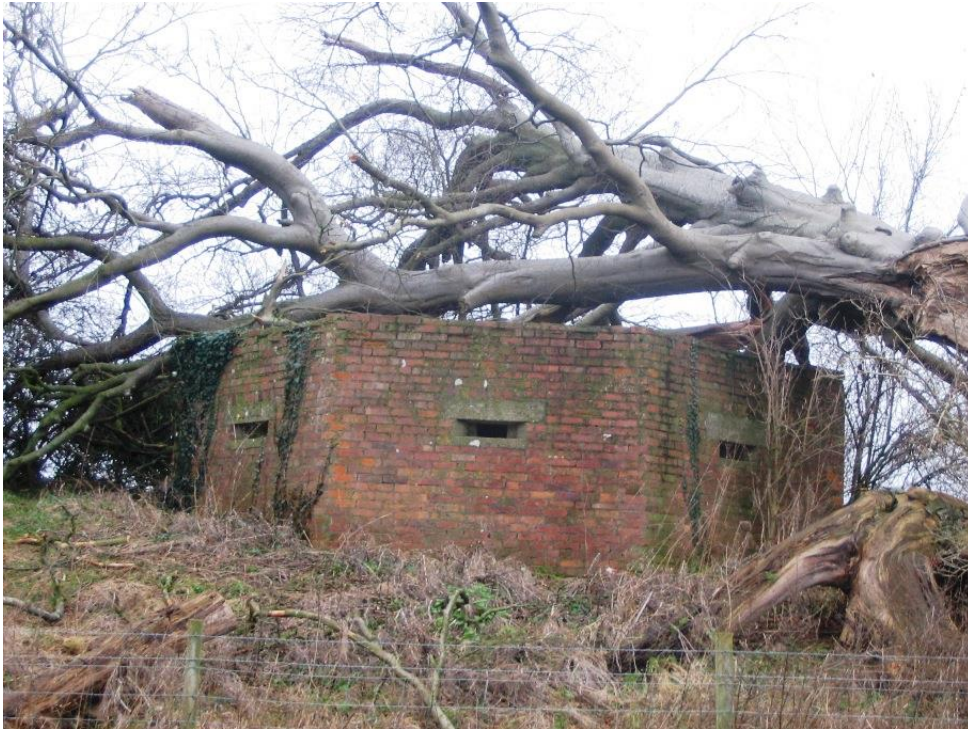
Number 3

3.1 View from the South

Pill box 3 is another type 24 but in much the best condition of any on the estate; the brickwork is sound and none have fallen. When initially surveyed a large beech tree had come down and was lying on top of the structure. There did not appear to be any damage.

Access is possible to the interior and it is dry and tidy. This pillbox was sited to give control of the Rey Mill area of the river, Rey Mill itself is clearly visible through the SW firing slit

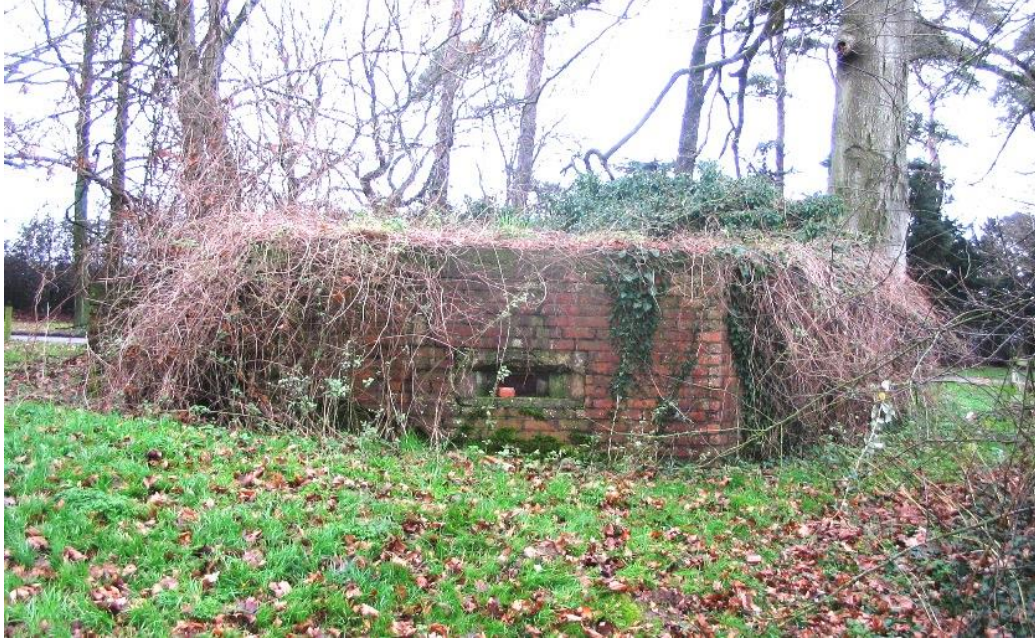
Number 5

5.1 View from the south east

This is a type 21 structure, situated just inside the wooded area west of the fields west of Lackham House, at the top of the slight rise on the Front Drive. It faces across the pasture land towards the House and the Back Drive, and lies directly to the south of the Front Drive. The drive can be seen in the background of figure 5.1.

Currently the brickwork is in good condition with little damage, but there are substantial trees growing against the northern side and brambles are growing over it, obscuring it from view from the Drive. It is likely that the tree roots will damage the structure in the future if they have not already done so.

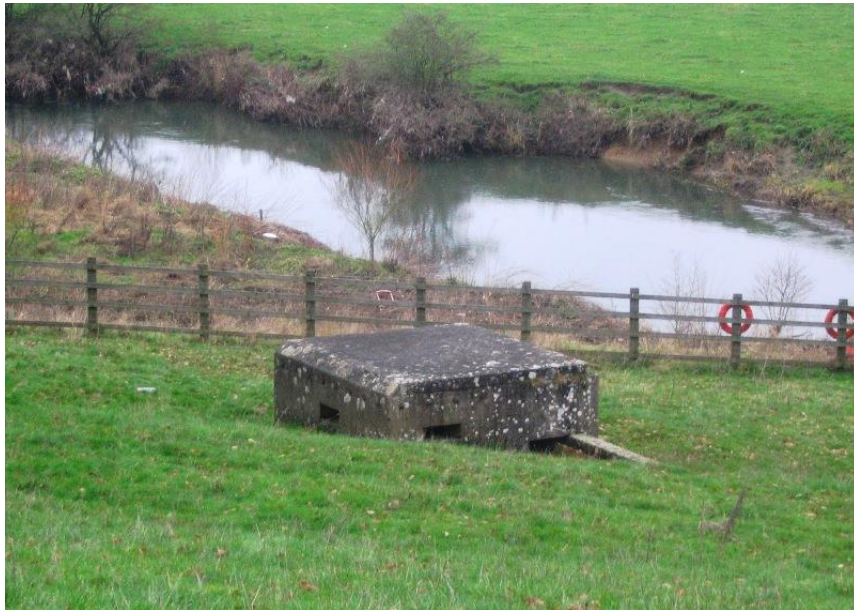
Number 6

This is a Type 26 structure, one of those made from pre-fabricated sections. The type 26 was square in plan, each wall being 10 feet (3 m) long. There is a door in one side and embrasures in each of the remaining three with no internal

walls The walls here are constructed to bullet proof standard, about 18 inches (45 cm) thick. It is therefore much smaller than any of the others and is positioned on the northern side of the estate, at the confluence of the River Avon and a small brook that runs in from the west. Much of the structure is above ground. The entrance trench is to the south of the main body of the structure. The panel forming the western side of the entrance trench side has partially collapsed on top of the eastern side, and access is difficult. Inside the structure is sound and dry and cramped.

6.1 View from the high ground to the south

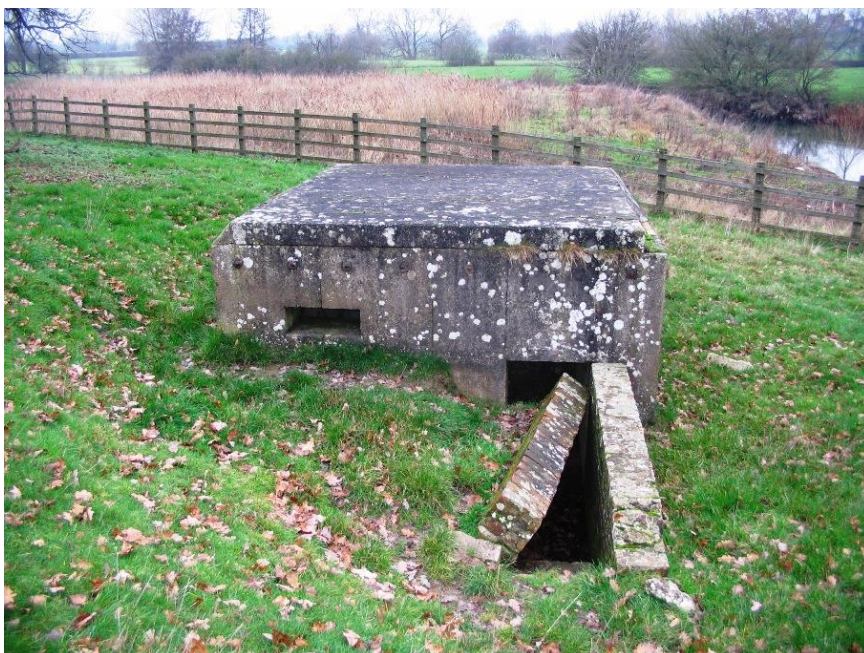
6.2 Southern entrance

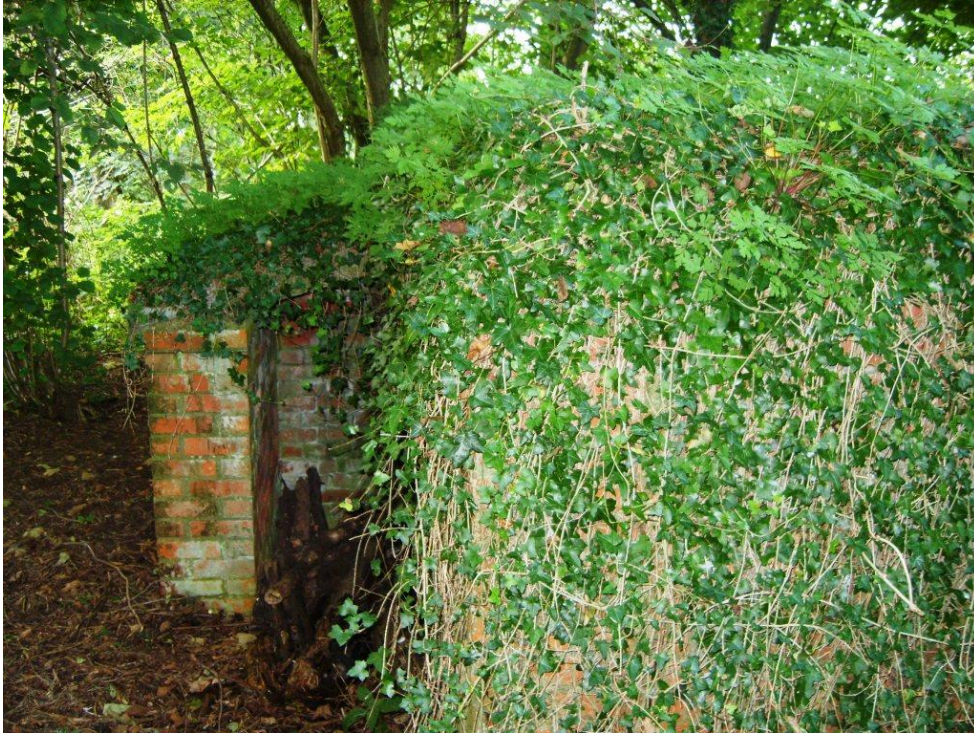
Number 7

7.1 Entrance on south side

This is another Type 24 octagonal structure, located at the north eastern end of North Wood, and so upstream of numbers 1 & 2. It is now completely enclosed in the woodland but is situated on a rise immediately south of and above the river bank. The brickwork cover is in excellent condition, one of the best preserved on the estate and the condition inside is good. Little idea of the field of fire can be gained because of the woodland growth but it would have commanded a long reach of the river north and east of the House.

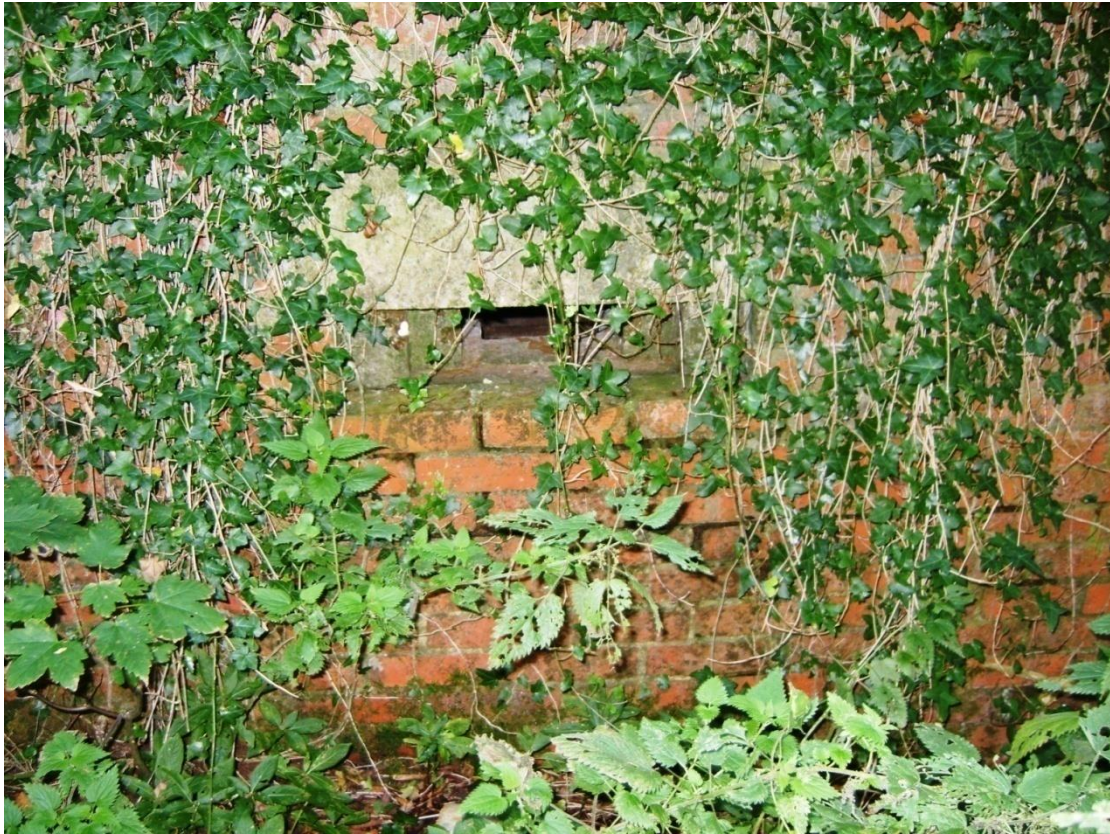
7.2 Embrasure on eastern side, note brick skin
